Soils and Foundations

Slope failures in residential land on valley fills in Yamamoto town

As a result of the 2011 off the Pacific Coast of Tohoku Earthquake, five slope failures occurred in a residential area on artificial valley fills in Taiyo New Town, Yamamoto, Miyagi Prefecture. The site was constructed by leveling a hilly area and using the cut materials as fill for the valleys to provide foundation ground for houses. The fill material was sandy and was derived from the weathering of tuffaceous sandstone which had formed the natural ground. Each of the five slope failures was observed to have occurred either at the edge of the artificial valley fills or within the embankment sections that had been widened for road construction. Laboratory tests show that the fill, which had a fines content of $F_c=20\%$, had a very low liquefaction resistance, which further decreased with the application of initial shear stress. A pseudo-static slope stability analysis, using conventional strength parameters, could not explain the slope failure at one of the sites that failed, but it could explain the slope failure when the dynamic strength was used to represent the soil strength at the slip

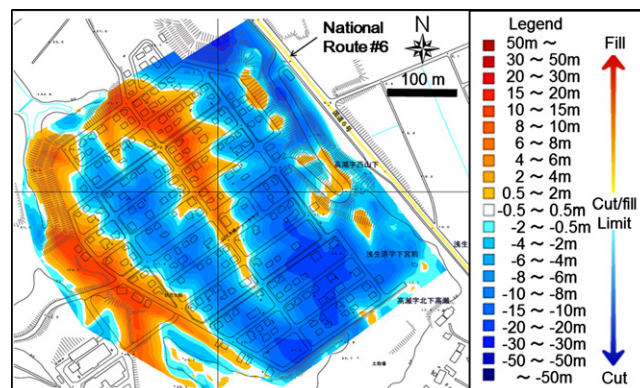
Fig. 2. Housing site foundation map of Taiyo New Town, showing thickness distribution of cut and fill sections (Fukken Gijutsu Consultant, 2008).

Comparing the locations of the failed blocks at the housing site (Fig. 5) with the foundation ground map shown in Fig. 2, it is clear that failed Blocks 1 and 2 occurred in the section of fills which was widened to construct the road, while Blocks 3, 4 and 5 occurred along the edge of the valley fills. This suggests that the fill material, rather than the natural ground, was involved in the slope failures.

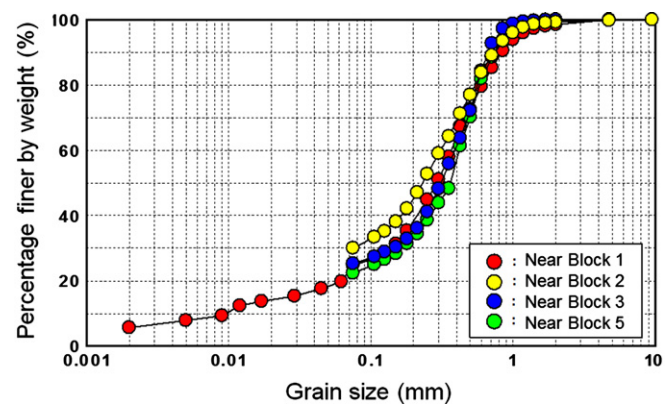
Soils samples were obtained near the failed blocks in order to investigate the geotechnical properties of the soil used as fill. Fig. 11 shows the grain size distribution curves for the samples from the three sites. It can be seen that the curves are fairly similar for all four locations, indicating that the fill materials were similar throughout the housing site. The soil has a well-graded grain size distribution with a fines content of $F_c = 20\%$.

Fig. 11. Grain size distribution curves of samples obtained from four locations.

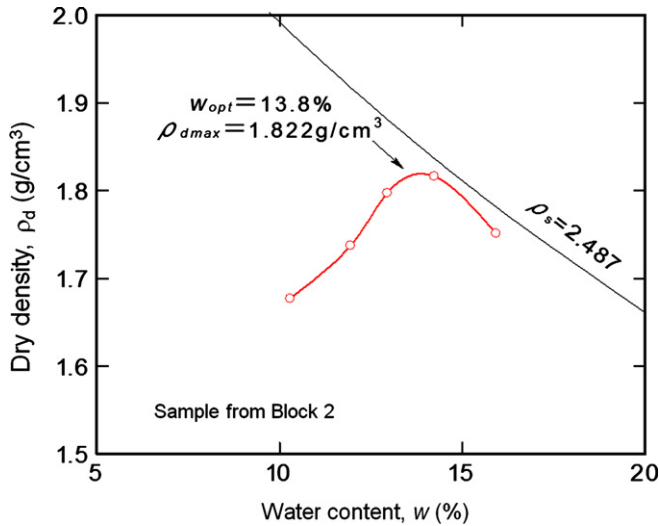
Samples obtained from the Block 2 site were quite abundant and they were used in most of the geotechnical laboratory tests. Index property tests, based on Japanese Geotechnical Society standards (JGS, 2000), showed that the density of the particles was 2.478 g/cm^3 , while the maximum and minimum densities were 1.319 and 1.079 g/cm^3 , respectively. Note that the latter values are quite small; a possible reason is that maximum and minimum density tests are designed for granular soils, not fine soils, especially ones with a fines content of $F_c = 20\%$. A compaction curve is shown in Fig. 12, where it is seen that the optimum water content is $w_{opt} = 13.8\%$, corresponding to a maximum dry density of $\rho_{dmax} = 1.822 \text{ g/cm}^3$.

Fig. 12. Compaction curve for Block 2 samples.

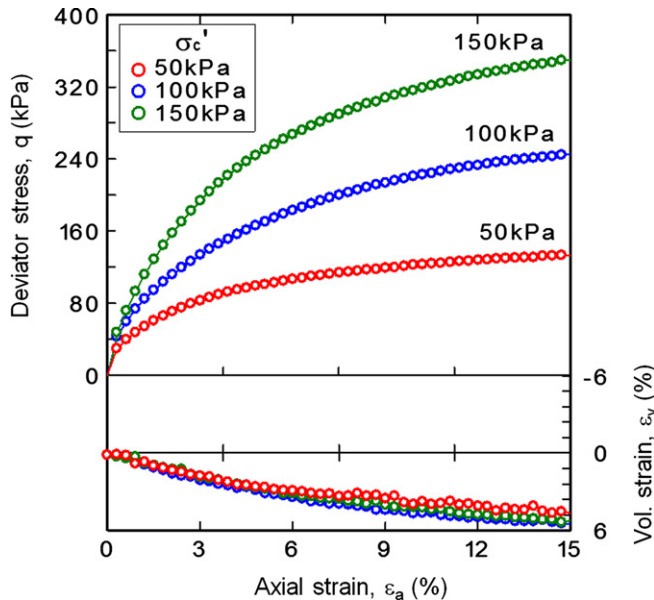
Fig. 13. Results of consolidated drained triaxial tests.

From the stress-strain relations, Mohr circles of stress were drawn at the residual state and the strength parameters were obtained. The results indicate the following values: cohesion $c' = 9$ kPa and angle of internal friction $\phi' = 31.7^\circ$. Such an internal friction angle is considered low for this type of dense sandy soil.

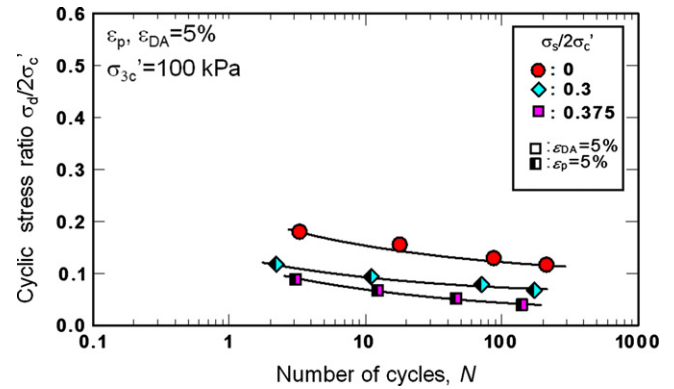
Cyclic undrained triaxial tests were performed on reconstituted samples under isotropically consolidated conditions. The obtained liquefaction resistance curve, corresponding to a double amplitude axial strain of $\varepsilon_{DA} = 5\%$, is shown by the solid circles in Fig. 14. It is seen that the liquefaction resistance of the material is quite low, indicating the susceptibility of the material to large deformation when shaken under saturated conditions. This may be due to the high proportion of non-plastic fines in the soil, which can decrease the liquefaction

Fig. 14. Liquefaction resistance curves of isotropically and anisotropically consolidated samples.

resistance (Hyodo et al., 2006), and to the density used to prepare the reconstituted specimens. Note that for soil specimens with a degree of compaction of $D_c = 90\%$, the dry density of the soil was taken as 1.64 g/cm^3 . According to the Yamamoto Town Office, dry densities ranging from 1.44 – 1.54 g/cm^3 were obtained at the site based on previous site investigations. Thus, although the density of the specimen used in the test was higher than the in situ values, the liquefaction resistance of the soil was low. Although the location of the water table during the earthquake was not confirmed, this type of material will liquefy easily when subjected to cyclic shearing induced by an earthquake, and will fail due to the reduction in effective stress.

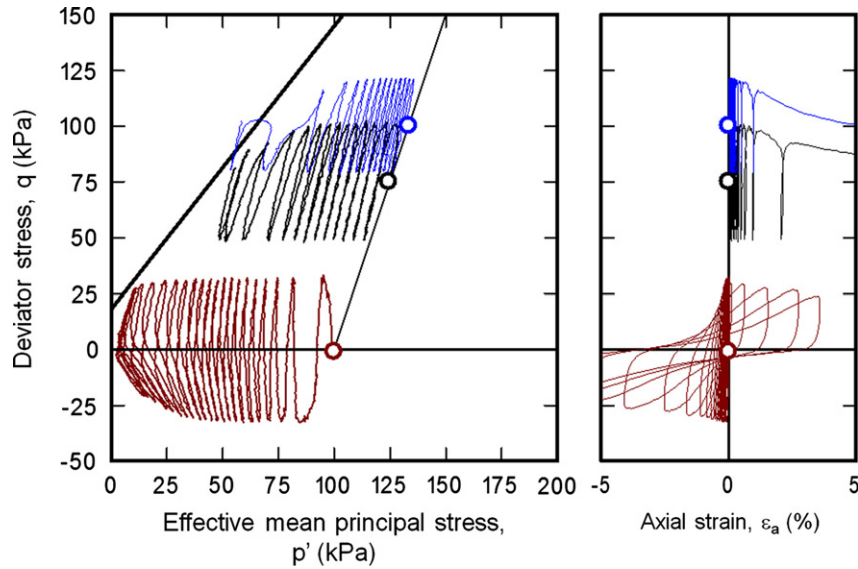
Fig. 15 shows the stress paths and the stress–strain relations for the cases of $\sigma_s/2\sigma'c = 0, 0.30$ and 0.375 . It can be observed that in all cases, the effective stress did not decrease to zero; however, large deformation suddenly developed after a certain number of loadings. This is more pronounced in the cases of $\sigma_s/2\sigma'c = 0.30$ and 0.375 . Thus, in both cases, failure occurred as a result of large deformation.

Fig. 15. (a) Stress paths and (b) stress–strain relations for cases of $\sigma_s/2\sigma_c' = 0, 0.30$ and 0.375 .

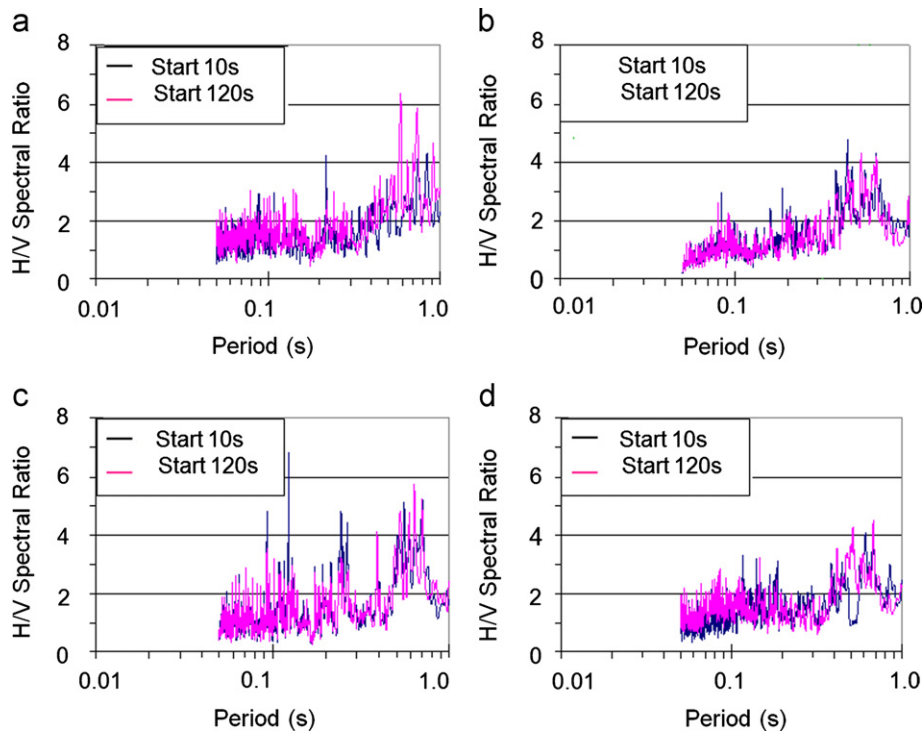
Fig. 16. Horizontal-to-vertical (H/V) spectral ratios obtained from microtremor measurements. (a) Near Block 1, (b) Near Block 3, (c) Near Block 5 and (d) South of Block 5.

To determine the natural period and other dynamic characteristics of the fill, microtremor measurements were conducted on top of the embankment near the location of the failed slopes. This method does not require any boreholes and is more convenient and cheaper than the traditional borehole method. Plots of the horizontal-to-vertical (H/V) spectral ratio of microtremors at each site are shown in Fig. 16. The plots were done at two time

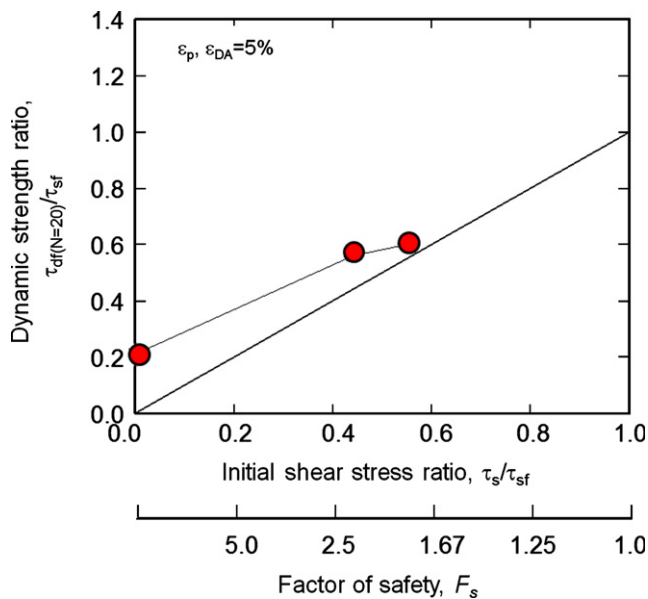
Fig. 18. Relation between dynamic strength and initial shear stress obtained from cyclic triaxial test results.

Since the calculated factor of safety, F_s , indicates the ratio of shear resistance τ_{sf} and shear stress τ_s along the slip surface (i.e., $F_s = \tau_{sf}/\tau_s$), it is possible to estimate the average static shear stress along the slip plane from the known values of F_s and τ_{sf} . From Fig. 14, the cyclic shear resistance ratios corresponding to $N=20$ cycles were read from the curves. Note that 20 cycles is usually taken as the representative number of cycles applied to define the liquefaction resistance of soils, as specified in many design codes (e.g., JRA, 1996). For earthquakes of this magnitude, however, the number of representative cycles should be large. In the absence of clear-cut guidelines on the number of representative cycles for a magnitude 9 event, $N=20$ is deemed appropriate. Moreover, looking at the gentle liquefaction resistance curves shown in Fig. 14, there is not much difference if N is taken at 20 or 100 cycles. The data read from the curves were used to plot the dynamic strength ratio, τ_{df}/τ_{sf} , as a function of the initial shear stress ratio, τ_s/τ_{sf} , as illustrated in Fig. 18. Note that $\tau_{df} = \tau_d + \tau_s$, i.e., the cyclic resistance, is added to the initial static shear stress to obtain the dynamic strength. Thus, knowing the average static shear stress along a slip plane, the corresponding dynamic strength can be estimated. This is then used to represent the soil strength in performing the pseudo-static
